NorthConnex

Ambient Air Quality and Weather Monitoring Validated Report

1st July to 31st July 2021

Report No.: DAT17307

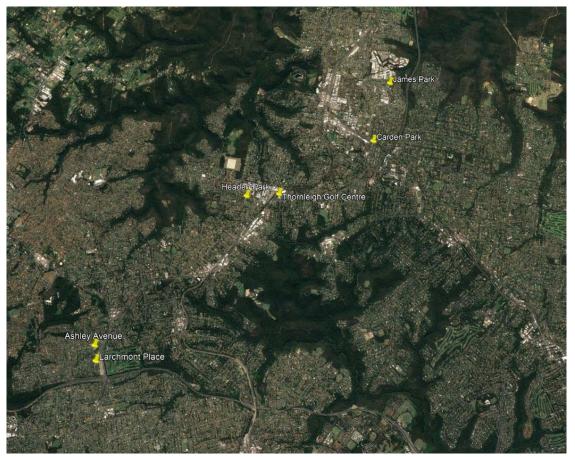
Figure 1: NorthConnex Project Monitoring Station Locations

Site Name	Geographical Coordinates	Height Above Sea Level (m)
Ashley Avenue	33°45′13.87″ S, 151 °2′45.11″ E	126
Carden Park	33°42′48.15″ S, 151° 6′33.10″ E	187
Headen Park	33°43′29.42″ S, 151° 4′ 44.38″ E	175
James Park Hornsby	33°42′2.28″ S, 151°6′48.59″ E	175
Larchmont Place	33°45′24.12″ S, 151°2′46.97″ E	110
Thornleigh Golf Centre	33°43′28.06″ S, 151°5′11.99″ E	182

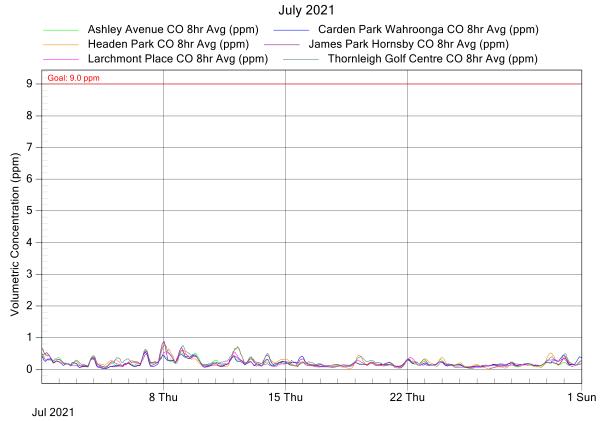
CO 8 Hour (rolling, based on 1 Hour Averages)

Figure 2: NorthConnex Project Air Monitoring Stations - CO 8 Hour Rolling Averages for July 2021

This section displays graphs of the pollutants and meteorological parameters monitored at the NorthConnex sites for July 2021. The graphs are based on validated 5 minute or 1-hour data as applicable.

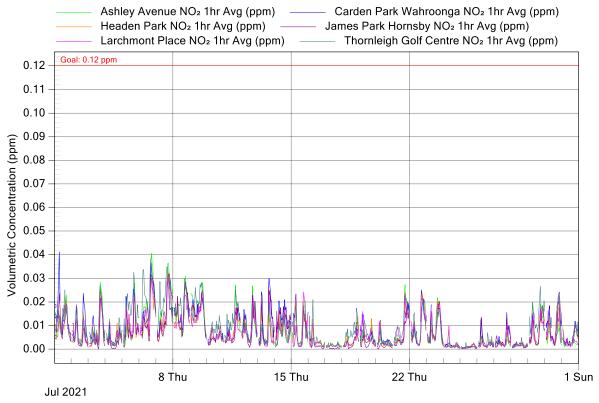
NO₂ 1 Hour Averages

Figure 3: NorthConnex Project Air Monitoring Stations - NO₂ 1 Hour Averages for July 2021

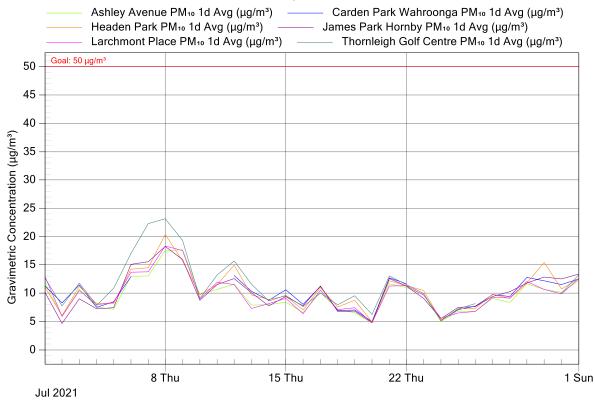
PM₁₀ 1 Day Averages

Figure 4: NorthConnex Project Air Monitoring Stations - PM₁₀ 1 Day Averages for July 2021

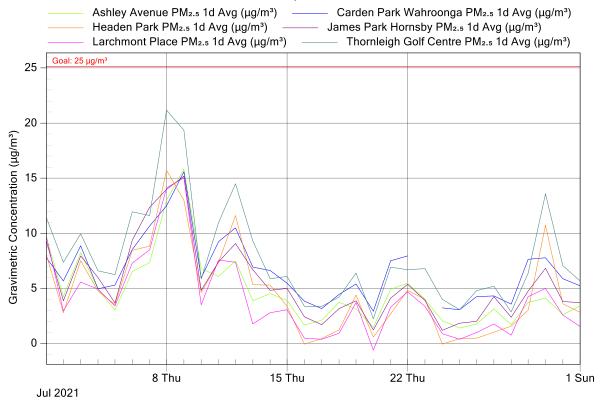
PM_{2.5} 1 Day Averages

Figure 5: NorthConnex Project Air Monitoring Stations - PM_{2.5} 1 Day Averages for July 2021

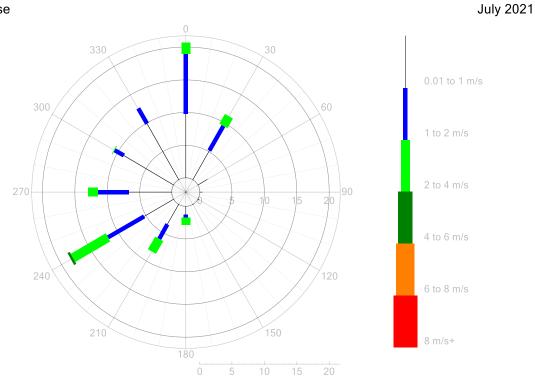
0.0% calm 99.6% valid data present

Figure 6: Ashley Avenue – Wind Rose for July 2021

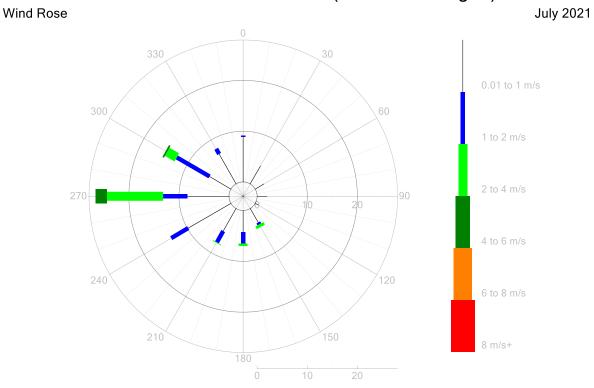
0.0% calm 96.1% valid data present

Figure 7: Carden Park – Wind Rose for July 2021

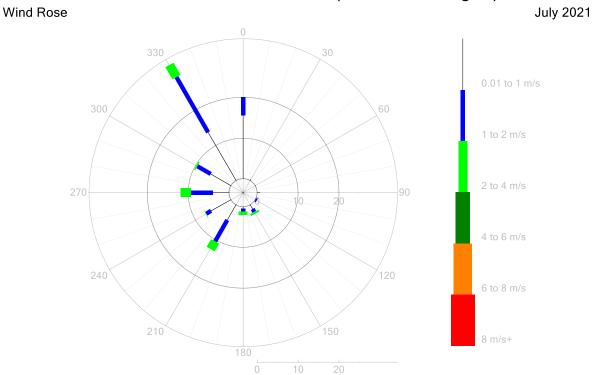
0.0% calm 98.9% valid data present

Figure 8: Headen Park – Wind Rose for July 2021

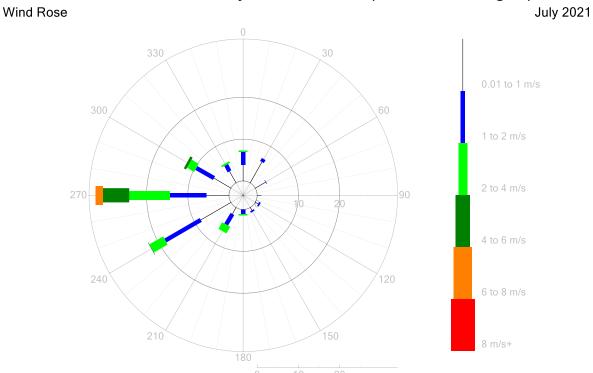
0.0% calm 99.2% valid data present

Figure 9: James Park Hornsby – Wind Rose for July 2021

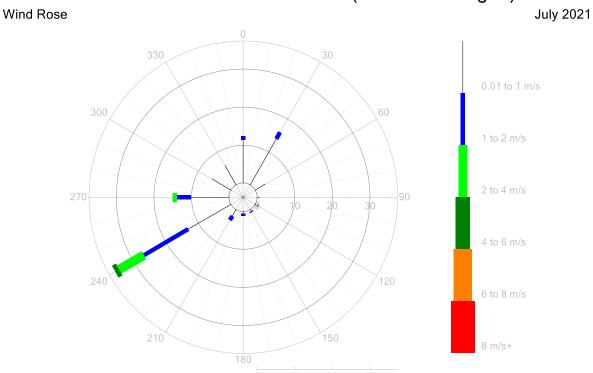
Larchmont Place - Wind Rose (1-Hour Averages)

0.0% calm 99.6% valid data present

Figure 10: Larchmont Place – Wind Rose for July 2021

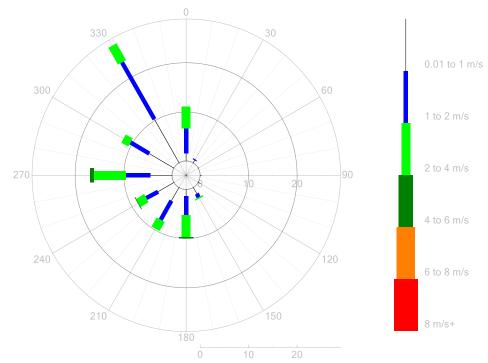
0.0% calm 98.7% valid data present

Figure 11: Thornleigh Golf Centre – Wind Rose for July 2021
