NorthConnex

Ambient Air Quality and Weather Monitoring

Validated Report

1st September to 30th September 2021

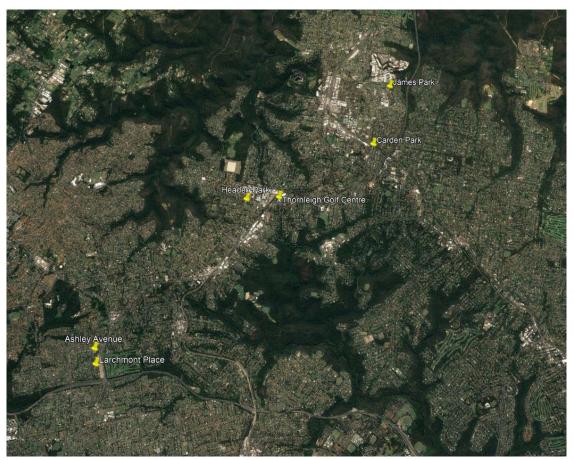
Figure 1: NorthConnex Project Monitoring Station Locations

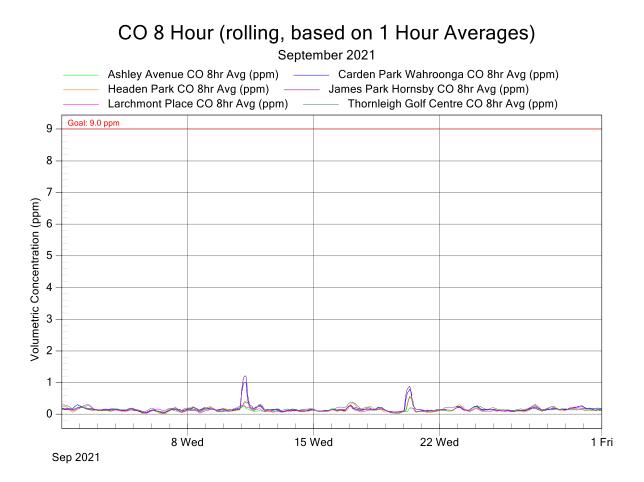
Figure 2: NorthConnex Project Air Monitoring Stations - CO 8 Hour Rolling Averages for September 2021

This section displays graphs of the pollutants and meteorological parameters monitored at the NorthConnex sites for September 2021. The graphs are based on validated 5 minute or 1-hour data as applicable.

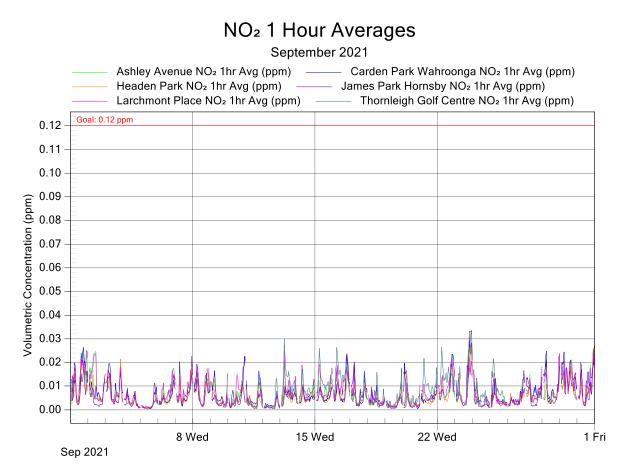
Figure 3: NorthConnex Project Air Monitoring Stations - NO₂ 1 Hour Averages for September 2021

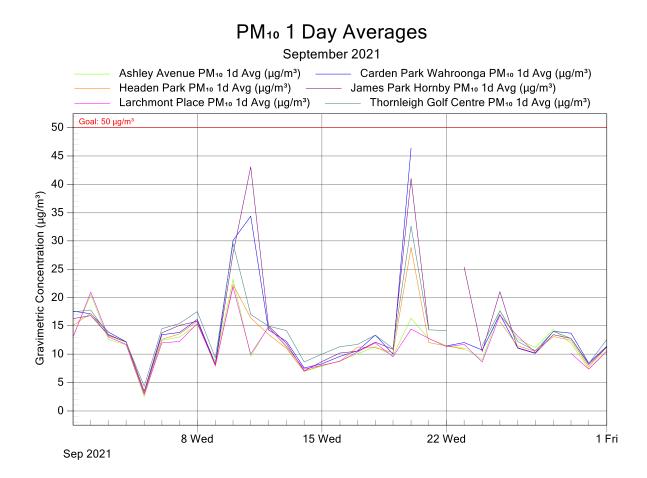
Figure 4: NorthConnex Project Air Monitoring Stations - PM₁₀ 1 Day Averages for September 2021

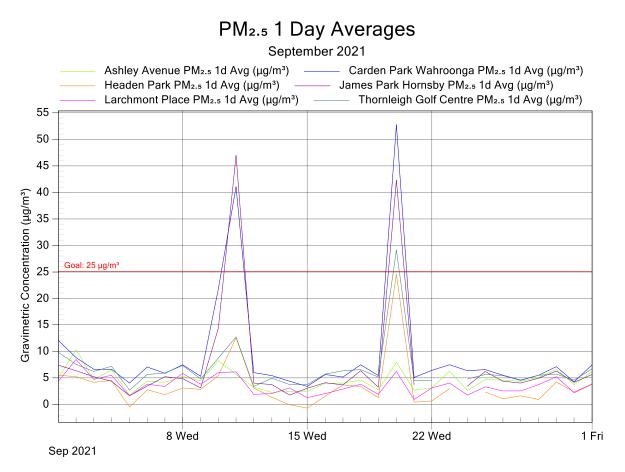
Figure 5: NorthConnex Project Air Monitoring Stations - PM_{2.5} 1 Day Averages for September 2021

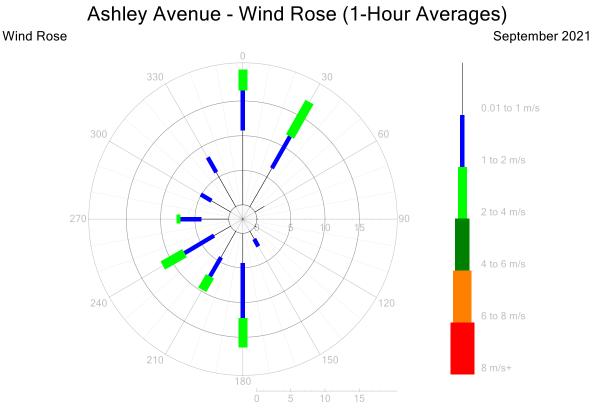
0.0% calm 99.6% valid data present

Figure 6: Ashley Avenue – Wind Rose for September 2021

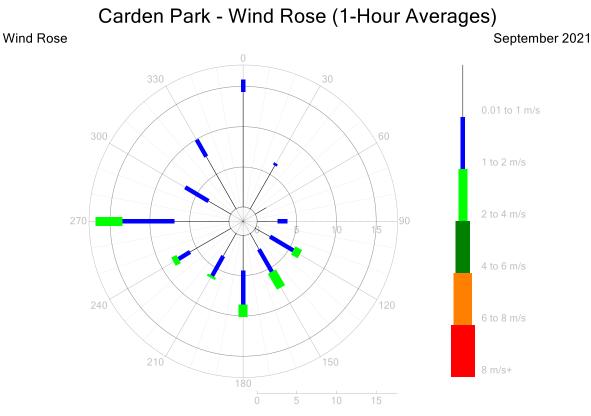
0.0% calm 98.5% valid data present

Figure 7: Carden Park – Wind Rose for September 2021

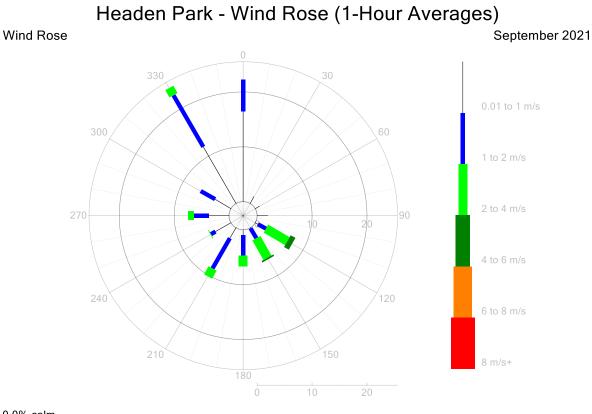
0.0% calm 99.0% valid data present

Figure 8: Headen Park – Wind Rose for September 2021

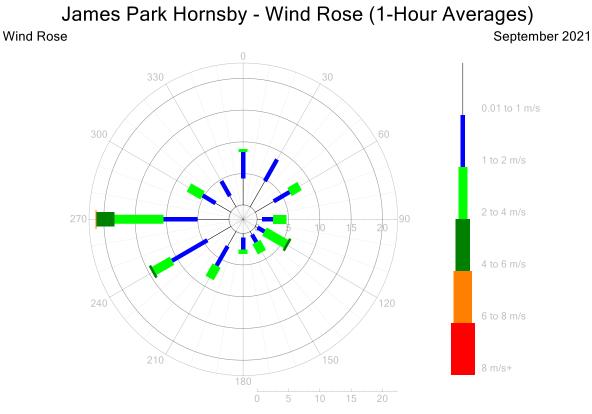
0.0% calm 98.5% valid data present

Figure 9: James Park Hornsby – Wind Rose for September 2021

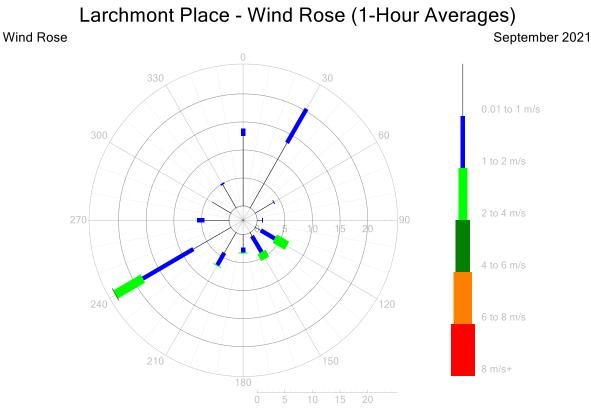
0.0% calm 99.2% valid data present

Figure 10: Larchmont Place – Wind Rose for September 2021

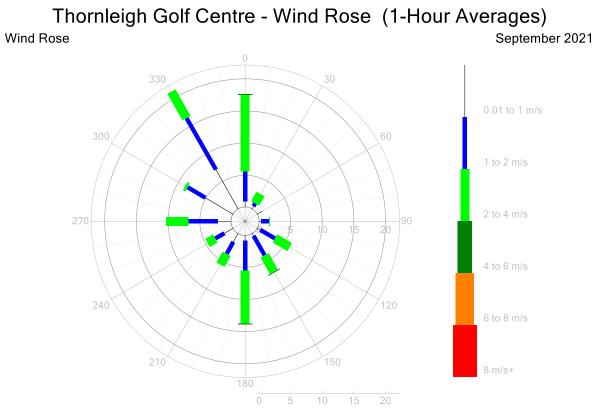
0.0% calm 98.8% valid data present

Figure 11: Thornleigh Golf Centre – Wind Rose for September 2021
