## NorthConnex

### Ambient Air Quality and Weather Monitoring

### Validated Report

1<sup>st</sup> June to 30<sup>th</sup> June 2021

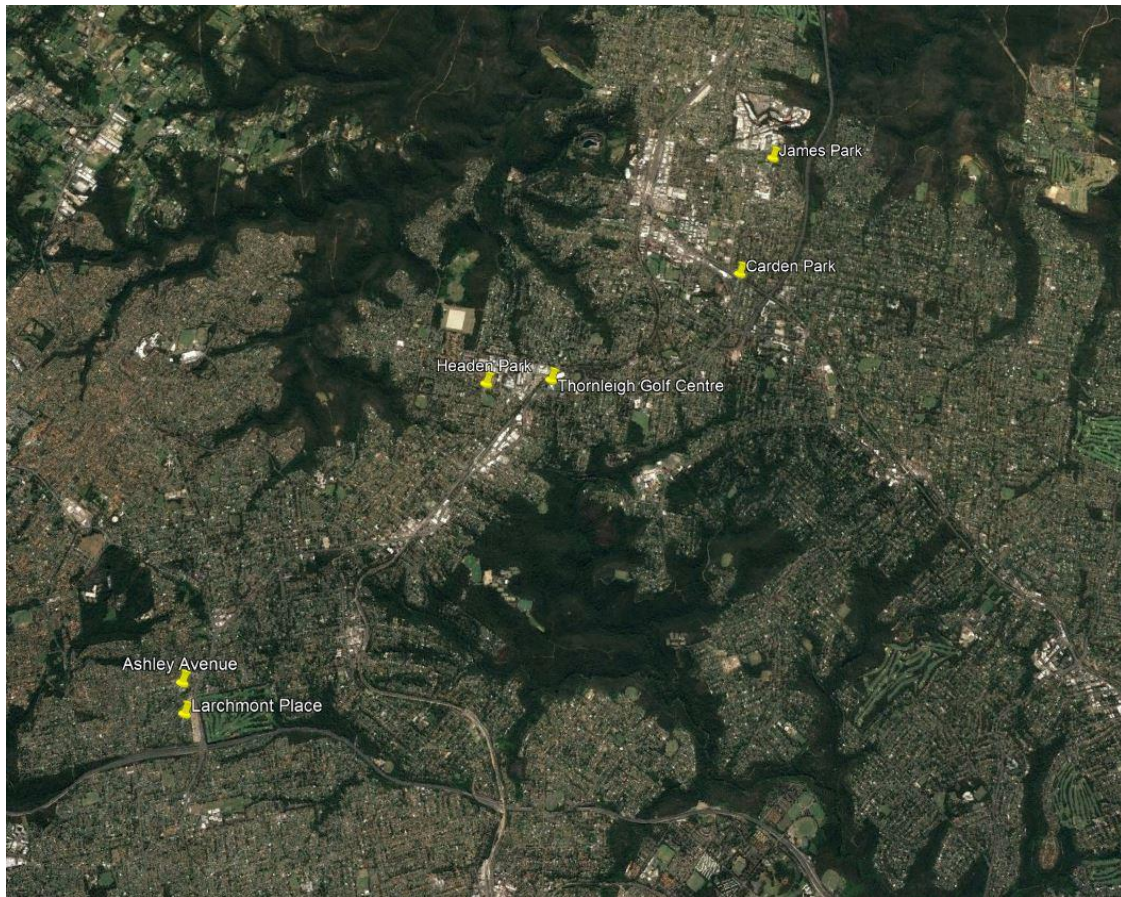
**Figure 1: NorthConnex Project Monitoring Station Locations**

The NorthConnex Project monitoring network consists of six ambient air quality and weather monitoring stations. The stations location and siting details are described below.

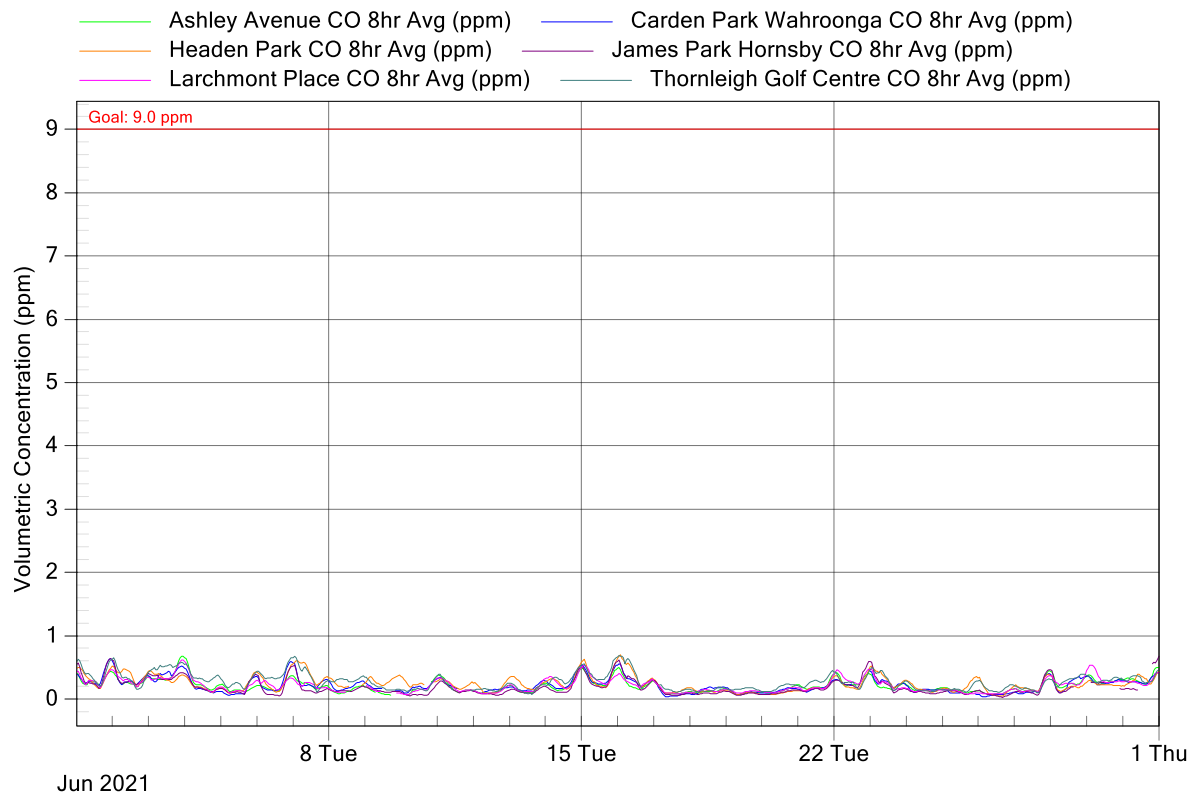
**Figure 2: NorthConnex Project Air Monitoring Stations - CO 8 Hour Rolling Averages for June 2021**

## CO 8 Hour (rolling, based on 1 Hour Averages)

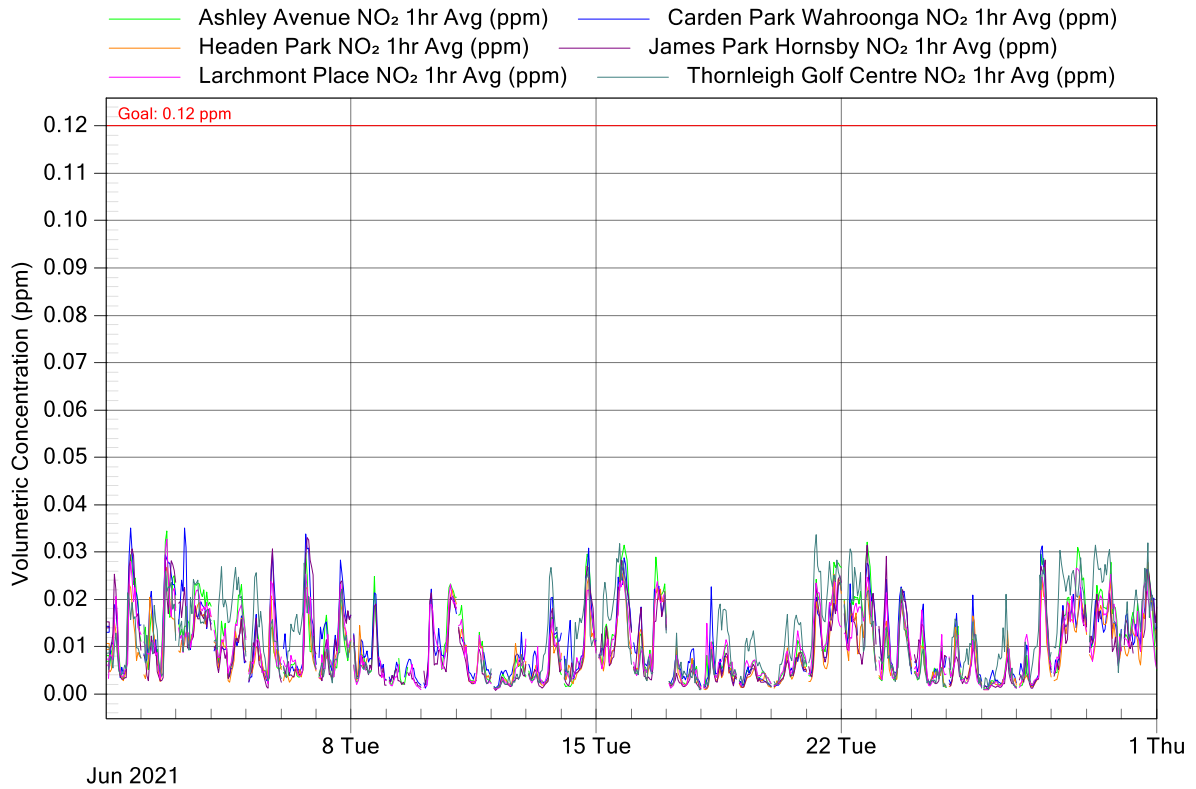
**Figure 3: NorthConnex Project Air Monitoring Stations - NO<sub>2</sub> 1 Hour Averages for June 2021**

### NO<sub>2</sub> 1 Hour Averages

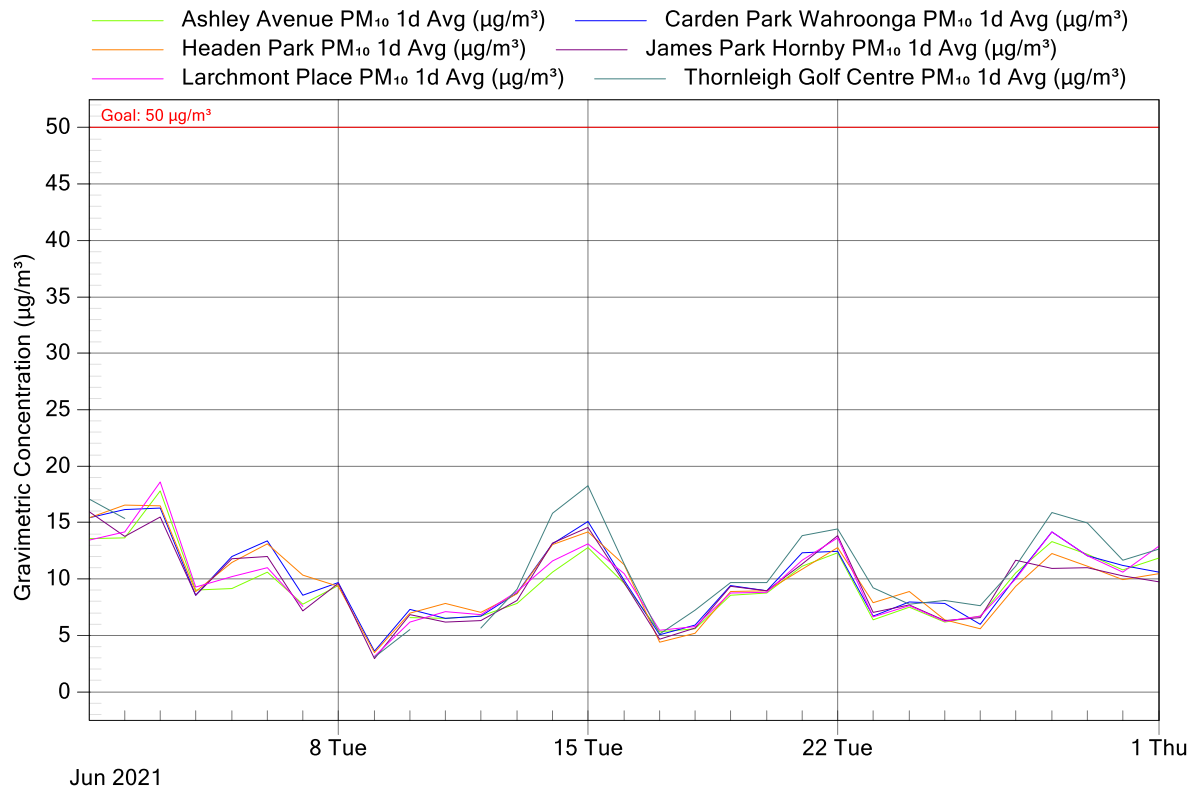
Figure 4: NorthConnex Project Air Monitoring Stations - PM<sub>10</sub> 1 Day Averages for June 2021

### PM<sub>10</sub> 1 Day Averages

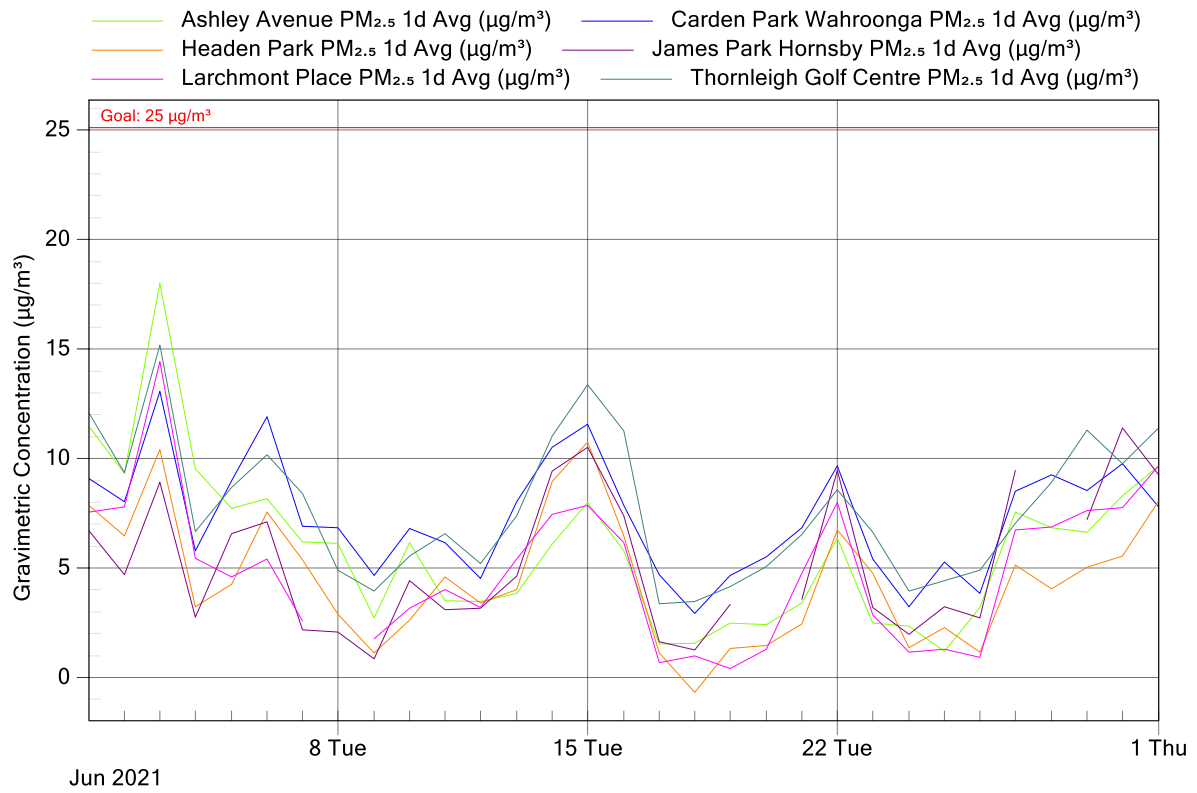
**Figure 5: NorthConnex Project Air Monitoring Stations - PM<sub>2.5</sub> 1 Day Averages for June 2021**

### PM<sub>2.5</sub> 1 Day Averages

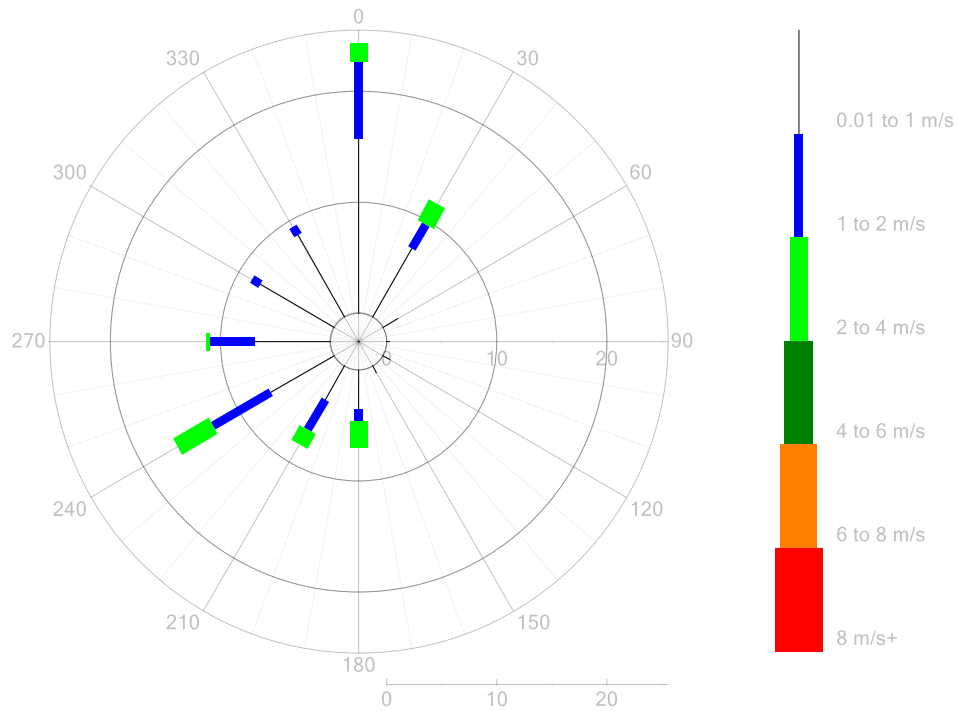
Figure 6: Ashley Avenue – Wind Rose for June 2021

0.0% calm  
98.5% valid data present

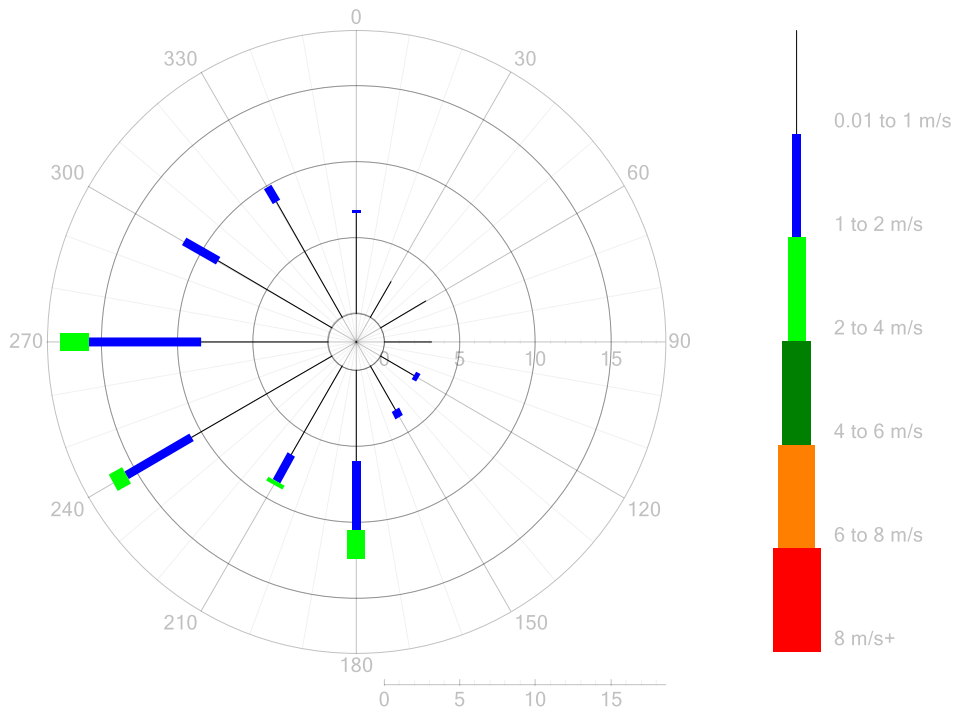
Figure 7: Carden Park – Wind Rose for June 2021

0.4% calm  
97.4% valid data present

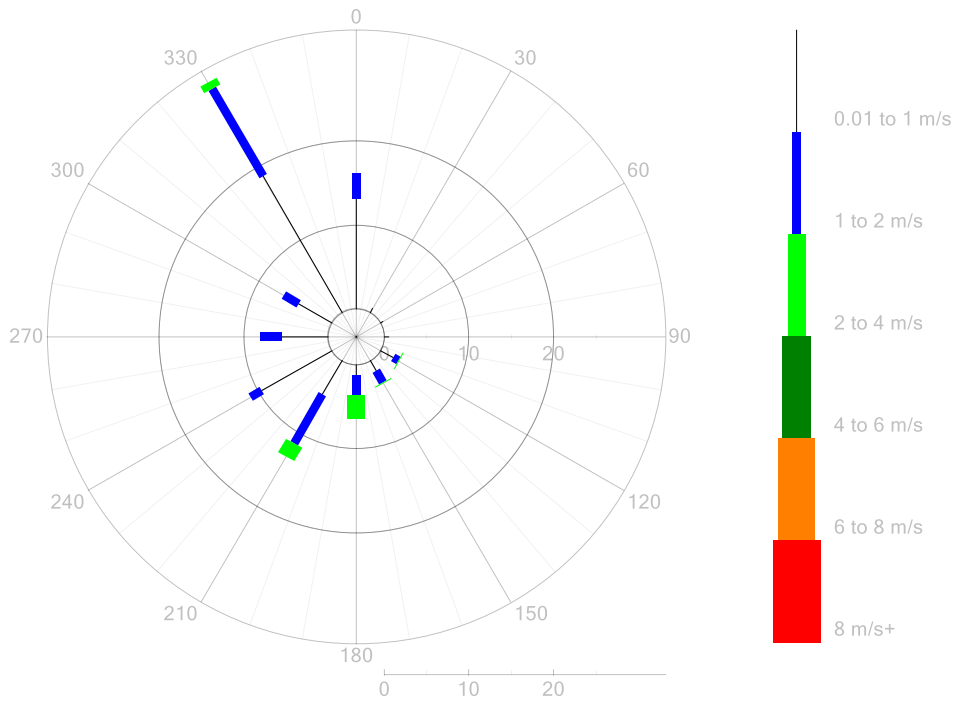
**Figure 8: Headen Park – Wind Rose for June 2021**

0.0% calm  
99.0% valid data present

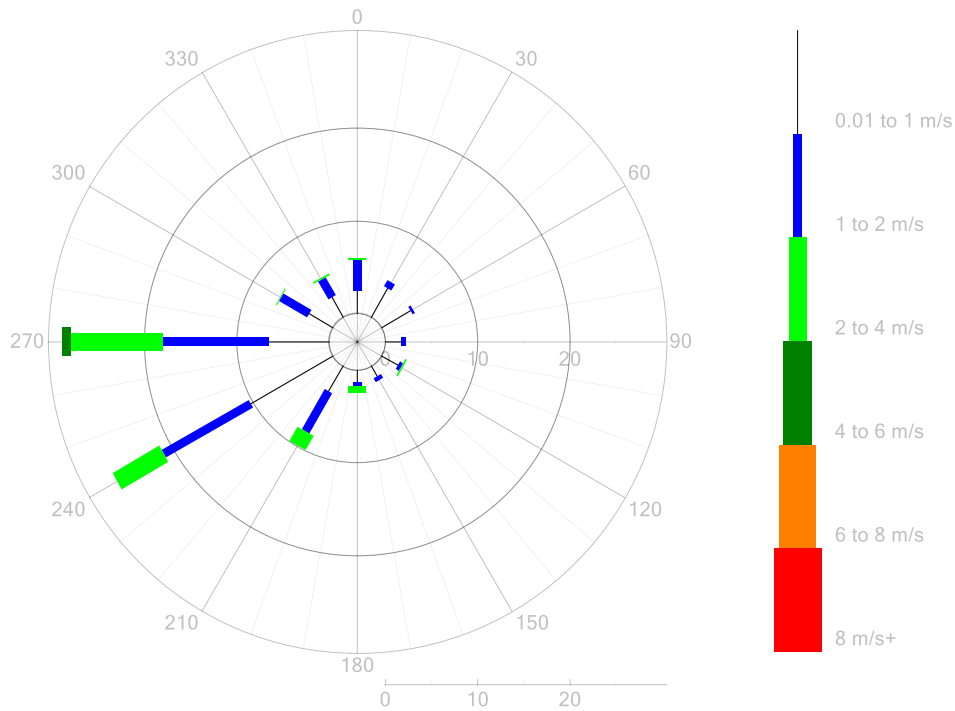
**Figure 9: James Park Hornsby – Wind Rose for June 2021**

0.0% calm  
97.4% valid data present

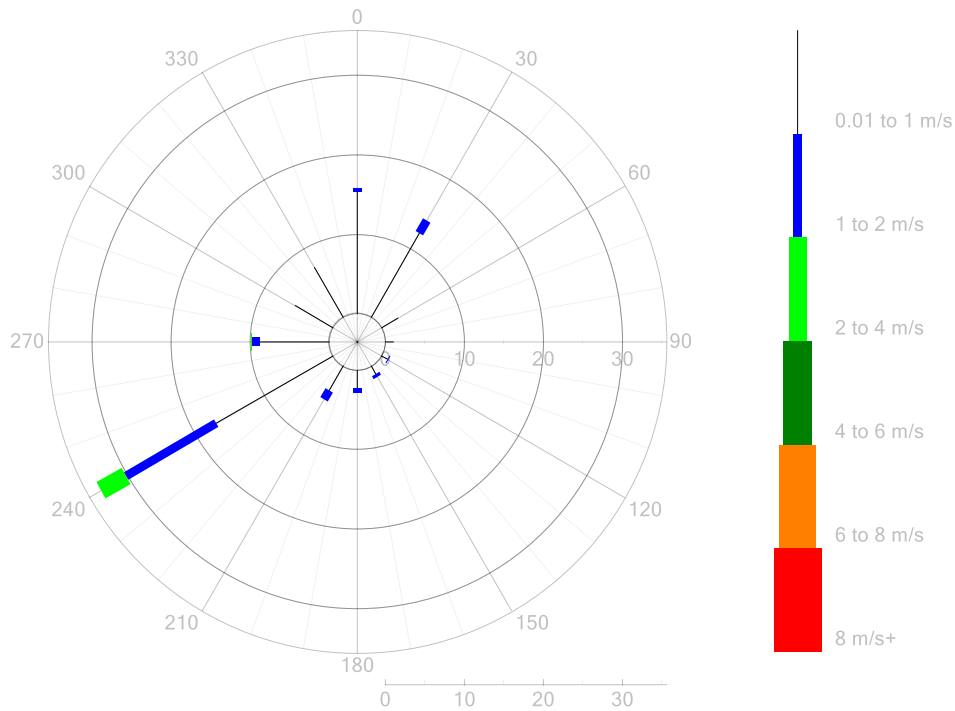
**Figure 10: Larchmont Place – Wind Rose for June 2021**

0.1% calm  
98.1% valid data present

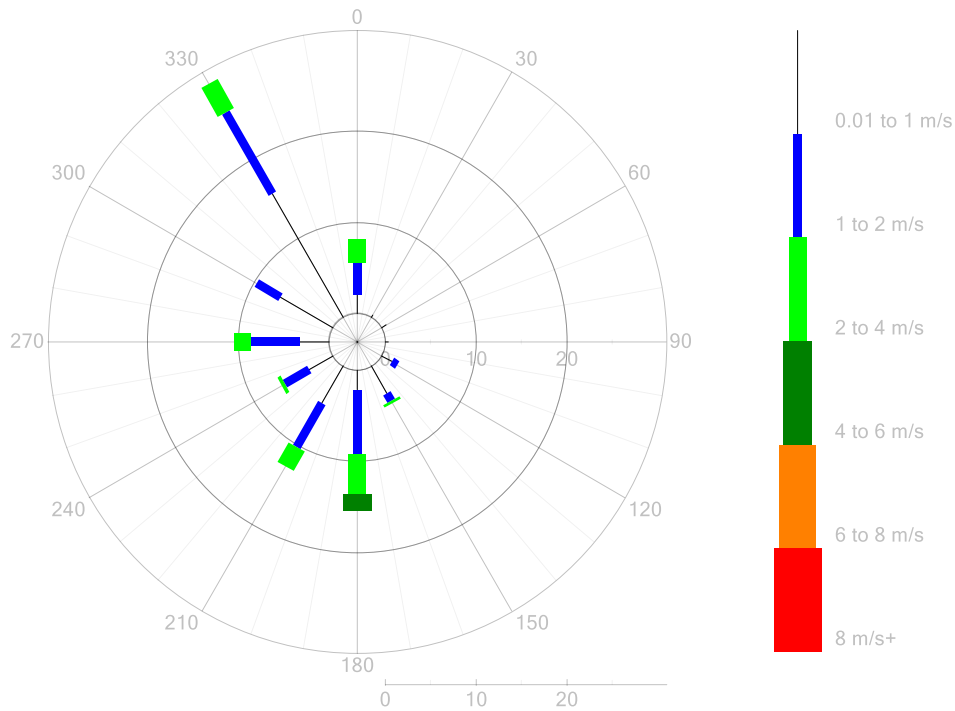
**Figure 11: Thornleigh Golf Centre – Wind Rose for June 2021**

0.0% calm  
98.1% valid data present
